Preventive Maintenance Guide for N-EVAP Model 11106-RT

Regular preventive maintenance will help extend the life of your N-EVAP and ensure consistent, trouble-free performance. This guide outlines the recommended maintenance procedure for a 6 position N-EVAP model 11106-RT.

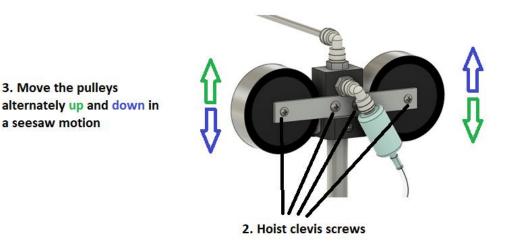
Hoist Alignment Video

- 1. Raise the manifold to its uppermost position and secure it in place by tightening the black thumbscrew.
- 2. Slightly loosen the 8 screws on the hoist assembly using a Phillips head screwdriver.
- 3. Using both hands, gently grasp both hoist pulleys and jiggle them a few times in a seesaw motion. Caution: band springs can be sharp. Take care not to cut your hands.
- 4. Lower and raise the manifold a few times using the black thumbscrew to realign the hoist.
- 5. Retighten the screws while the manifold is in its uppermost position.

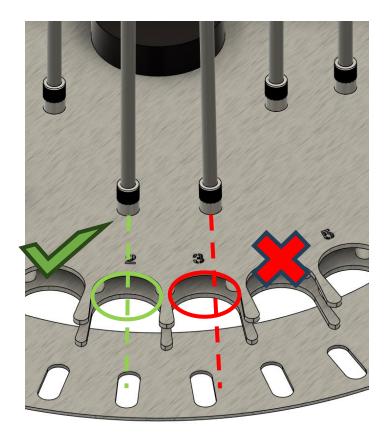
- 1. Remove the needle from one sample position.
- 2. Loosen the 3-part fitting for that sample position and lower the valve tube to just above the sample tray.
- 3. Use the provided hex key to loosen the two set screws on the sample holder plate collar.
- 4. Rotate the sample holder so that the valve tube is centered over a test tube position.
- 5. Tighten the set screws to hold the sample holder plate securely.
- 6. Raise the valve tube to its initial position and tighten the 3-part fitting to secure it in place.

Check the 3-part fitting for cracks and that each piece thread smoothly when paired together. The valve tube should not move laterally, or tilt, when the fitting is fully fastened.

Valve tubes should be straight and free of corrosion or residue. Any bends may restrict motion and/or gas flow. Clean off any residue with the non-abrasive pad provided.

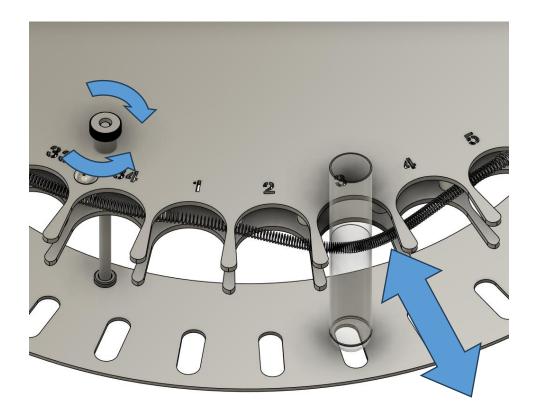
- 1. Confirm the support tray height can be freely adjusted. Alternate between rotating each of the 3 thumb nuts clockwise and counterclockwise.
- 2. Confirm the retention spring that holds samples in place can stretch/contract while returning to its original state.
- 3. Inspect the center collar for cracks.
- 4. Tighten the set screws to hold the sample holder plate securely to the center tube. It is possible for these set screws to loosen over time.

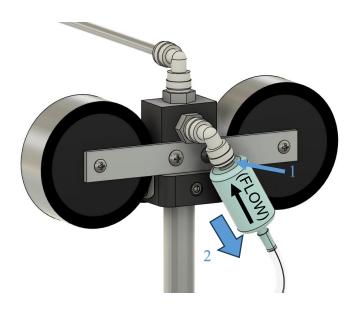
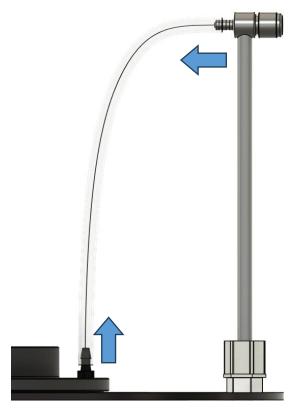
Air filter

The air filter is located above the flow meter on the right hoist pulley. Remove the old air filter by depressing the grey ring (1) to release the first fitting while pulling the filter (2) away from the fitting. Detach the flexible silicone tubing from the other side of the filter as well.

Connect the new filter in the same position. The flow arrow on the filter should point in, from the tube running from the flow meter towards the hoist pully.

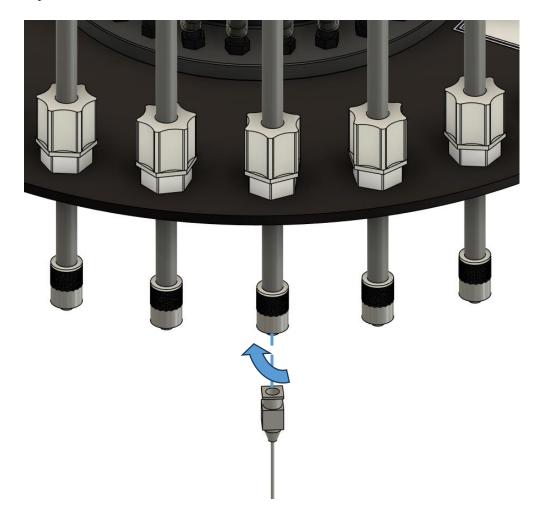
Remove old needles by rotating counterclockwise a quarter turn. Needles that are bent, corroded, soiled, or blocked should be discarded. Needles that are straight, clean, and unblocked can be retained as spares. Install new needles by rotating clockwise a quarter turn.
