## Preventive Maintenance Guide for N-EVAP Model 11155

Regular preventive maintenance will help extend the life of your N-EVAP and ensure consistent, trouble-free performance. This guide outlines the recommended maintenance procedure for a 12 position N-EVAP model 11155.

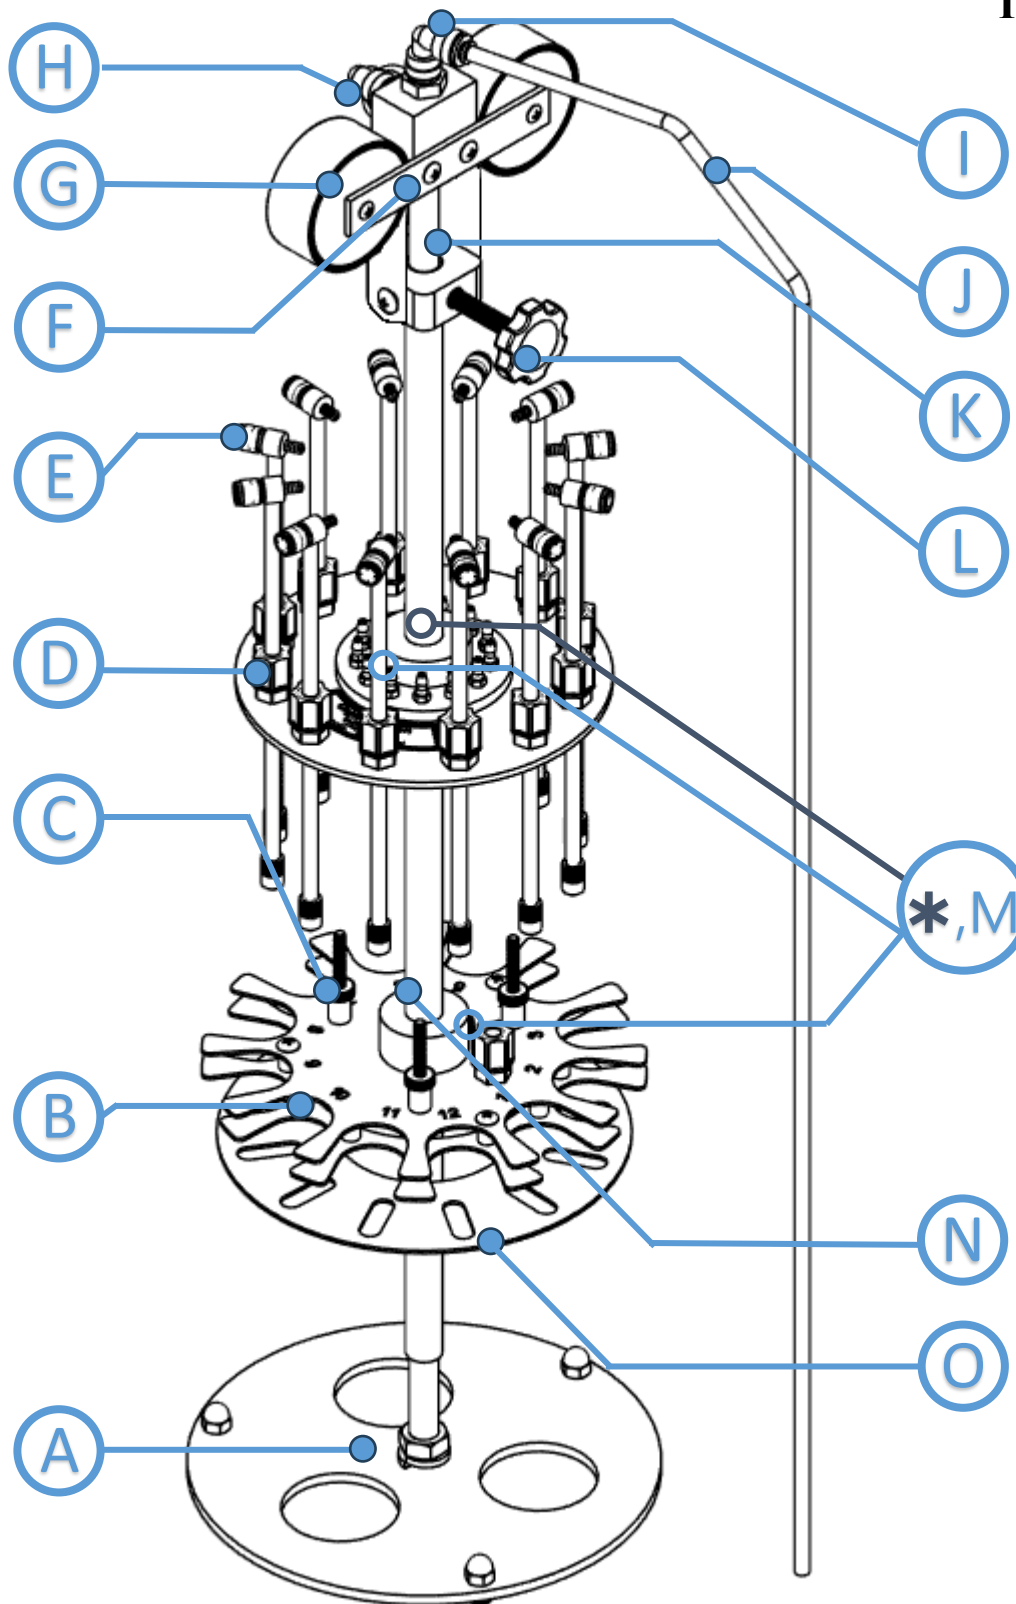
## Instrument Diagram

Instrument Component	
A	Base Stand
B	Sample Holder and Sample Spring
C	Thumb Nut
D	Tube Fitting
E	Valve Tube Assembly
F	Hoist Clevis
G	Hoist Pulley and Band Spring
H	Filter
I	Swivel Fitting
J	Gas Tube
K	8.25 Inch Rod
L	Hoist Knob
*	Set Screw Dimple
M	Set Screw
N	Center Tube
O	Support Tray

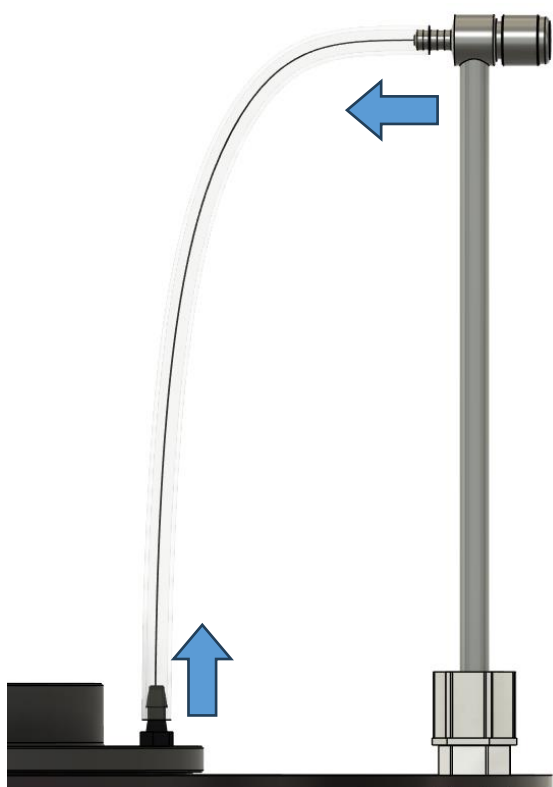
### Air filter

The air filter is located above the flow meter on the right hoist pulley. Remove the old air filter by depressing the grey ring (1) to release the first fitting while pulling the filter (2) away from the fitting. Detach the flexible silicone tubing from the other side of the filter as well.

Connect the new filter in the same position. The flow arrow on the filter should point in, from the tube running from the flow meter towards the hoist pulley.

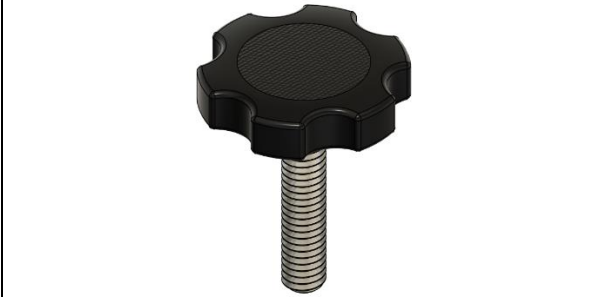
P0612-N	Hoist thumb screw	Check for cracks

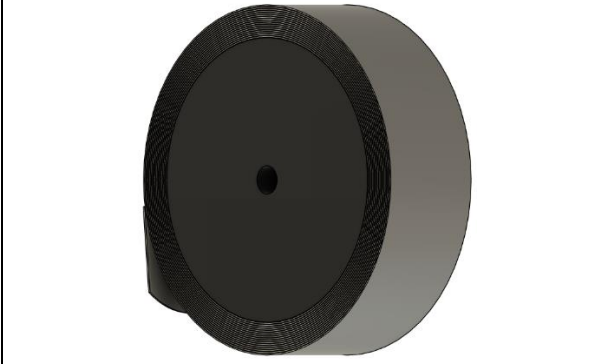
P1102	Hoist pulleys	Check for cracks, bowing, or significant corrosion
