Preventive Maintenance Guide for N-EVAP Model 11250-RT

Regular preventive maintenance will help extend the life of your N-EVAP and ensure consistent, trouble-free performance. This guide outlines the recommended maintenance procedure for a 24 position N-EVAP model 11250-RT.

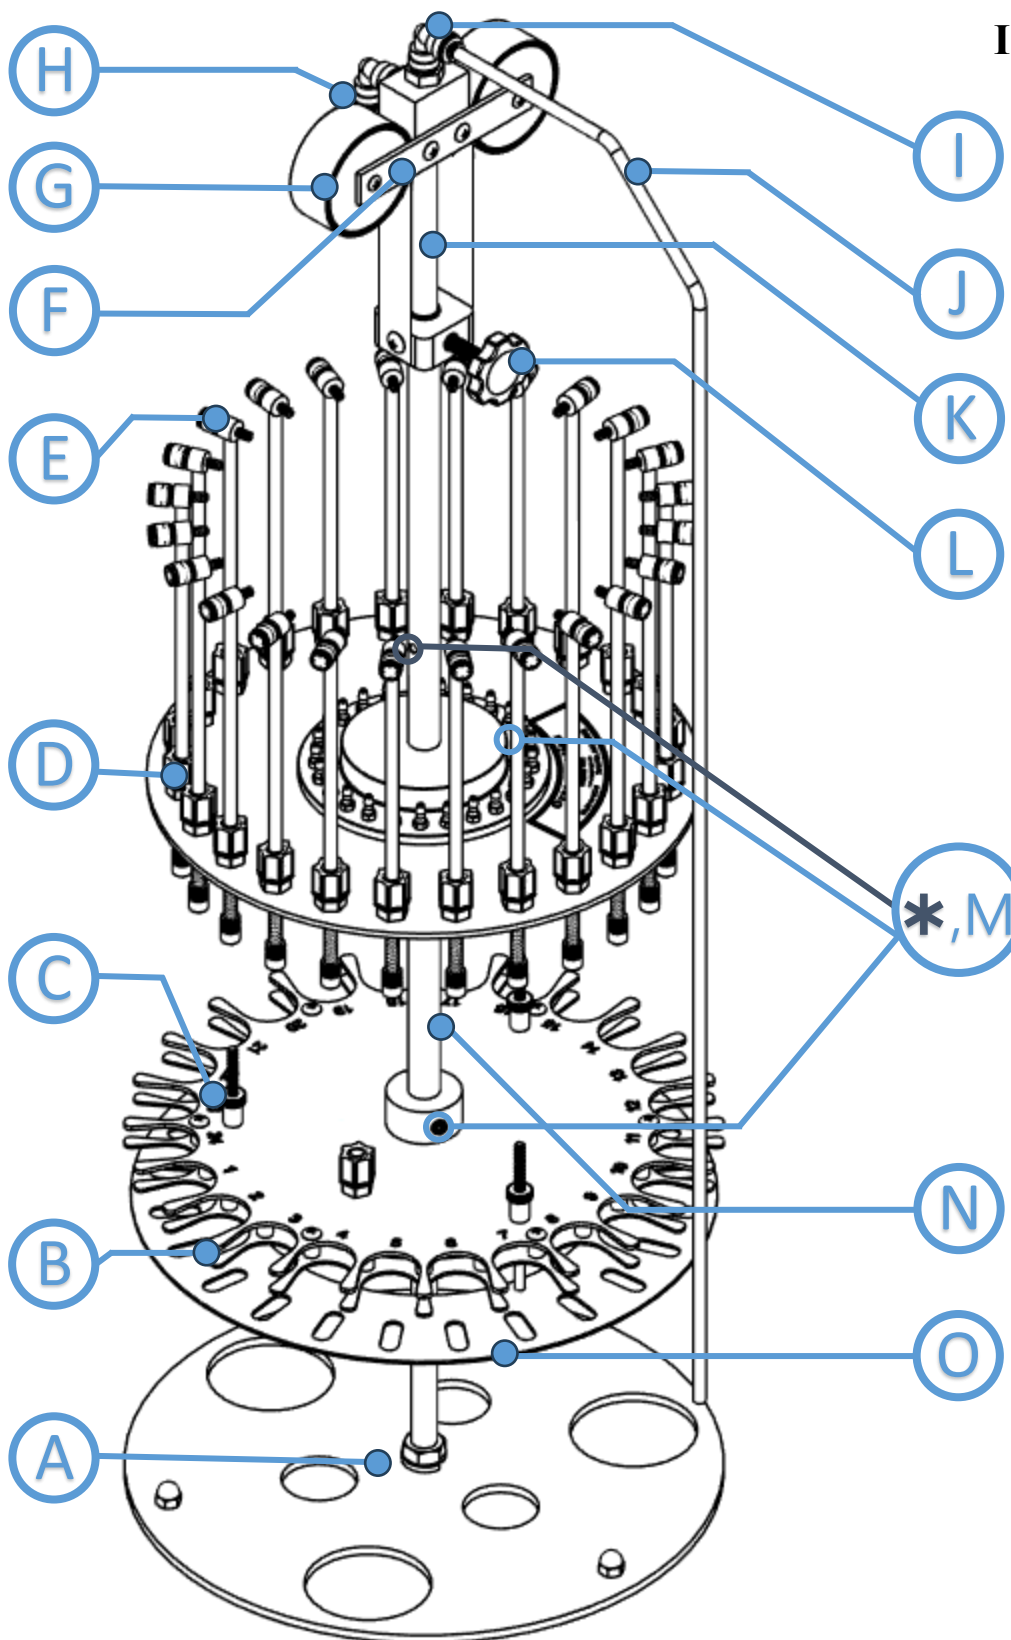
Instrument Diagram

Instrument Component	
A	Base Stand
B	Sample Holder and Sample Spring
C	Thumb Nut
D	Tube Fitting
E	Valve Tube Assembly
F	Hoist Clevis
G	Hoist Pulley and Band Spring
H	Filter
I	Swivel Fitting
J	Gas Tube
K	8.25 Inch Rod
L	Hoist Knob
*	Set Screw Dimple
M	Set Screw
N	Center Tube
O	Support Tray

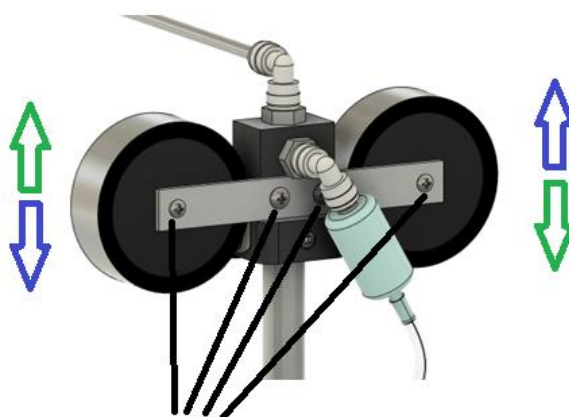
**3. Move the pulleys
alternately up and down in
a seesaw motion**

2. Hoist clevis screws

1. Raise the manifold to its uppermost position and secure it in place by tightening the black thumbscrew.
2. Slightly loosen the 8 screws on the hoist assembly using a Phillips head screwdriver.
3. Using both hands, gently grasp both hoist pulleys and jiggle them a few times in a seesaw motion. Caution: band springs can be sharp. Take care not to cut your hands.
4. Lower and raise the manifold a few times using the black thumbscrew to realign the hoist.
5. Retighten the screws while the manifold is in its uppermost position.

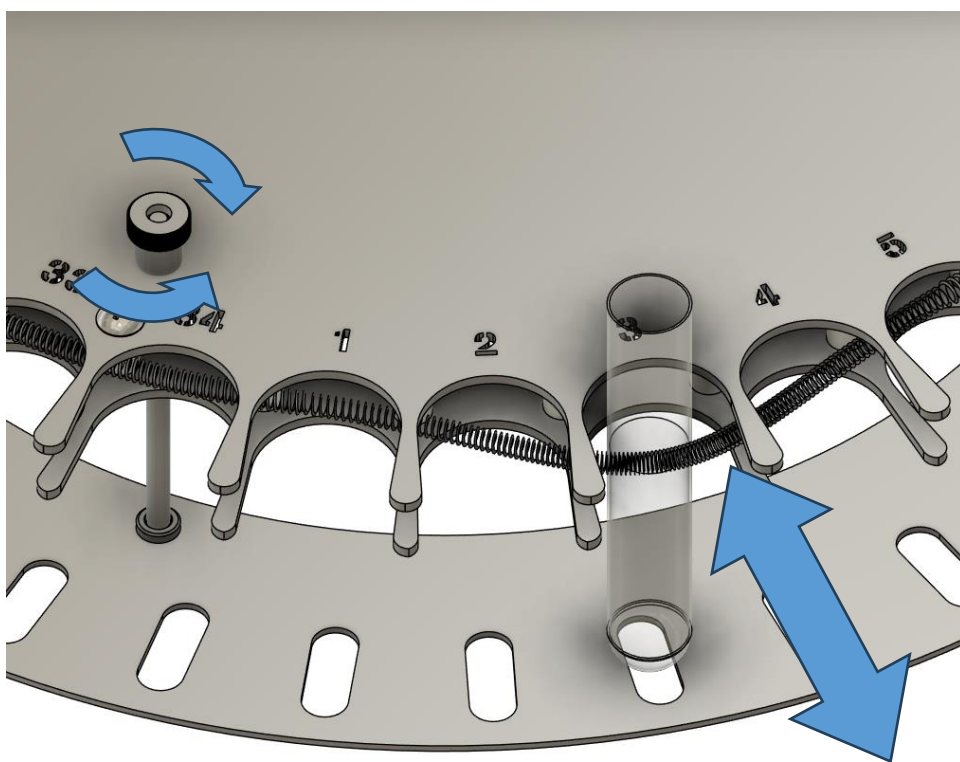
1. Confirm the support tray height can be freely adjusted. Alternate between rotating each of the 3 thumb nuts clockwise and counterclockwise.
2. Confirm the retention spring that holds samples in place can stretch/contract while returning to its original state.
3. Inspect the center collar for cracks.
4. Tighten the set screws to hold the sample holder plate securely to the center tube. It is possible for these set screws to loosen over time.

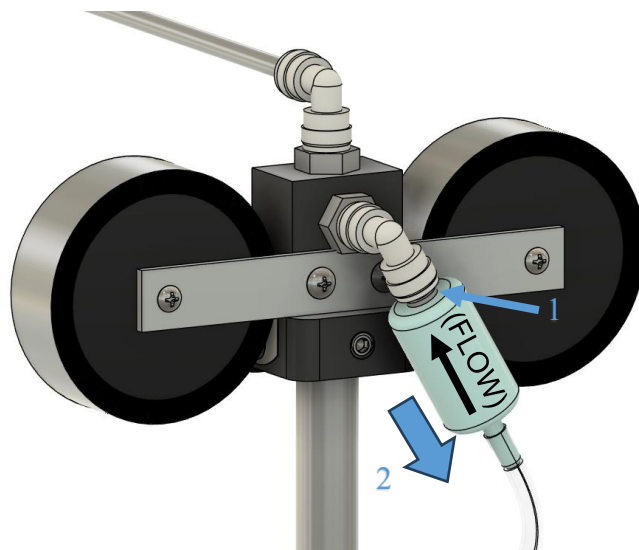
Air filter

The air filter is located above the flow meter on the right hoist pulley. Remove the old air filter by depressing the grey ring (1) to release the first fitting while pulling the filter (2) away from the fitting. Detach the flexible silicone tubing from the other side of the filter as well.

Connect the new filter in the same position. The flow arrow on the filter should point in, from the tube running from the flow meter towards the hoist pulley.

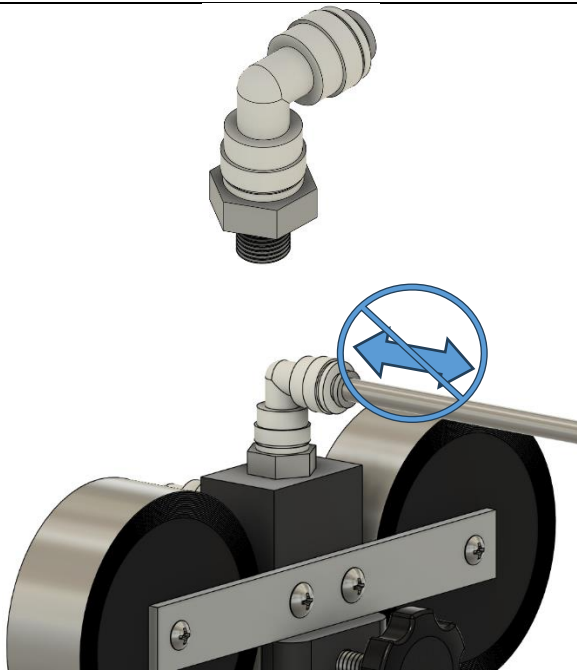
P1204	Upper swivel fitting	Should hold the stainless steel gas supply tube firmly in place.

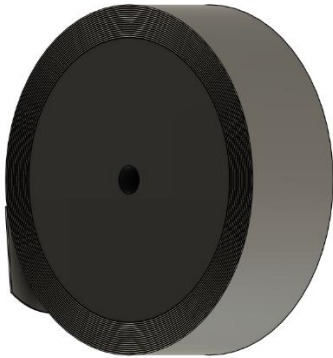
P1202 (P1224 for older models)	Hoist pulleys	<p>Check for cracks, bowing, or significant corrosion.</p> <p><i>If replacement is required:</i></p> <ul style="list-style-type: none"> - Pulleys 2.25" in diameter should be replaced with P1202 Pulleys 2.5" in diameter should be replaced with P1224

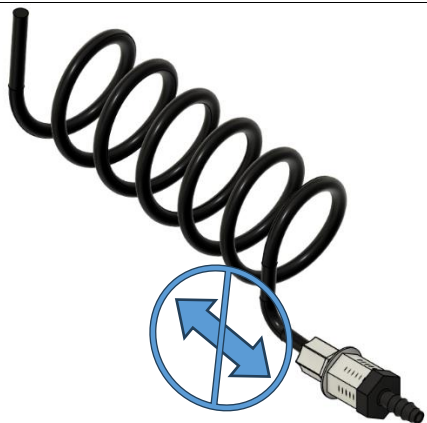
NA1101	Coiled gas connector tube	Check for leaks, kinks, or cracks. Make sure that tubing is still held securely in multi-part fitting.

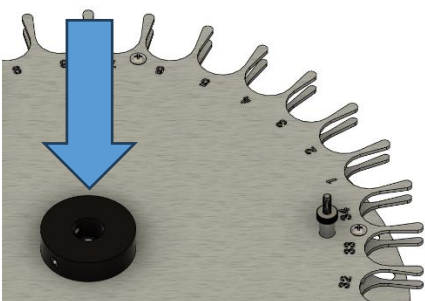
P1213	Collar on sample holder	Inspect for cracks.
